Manhole Inspection Summary

Manhole # S43SS_034MH

Insp Date: **2/22/07 1:28 PM**

Location Address: **1600 GORSUCH AVE**

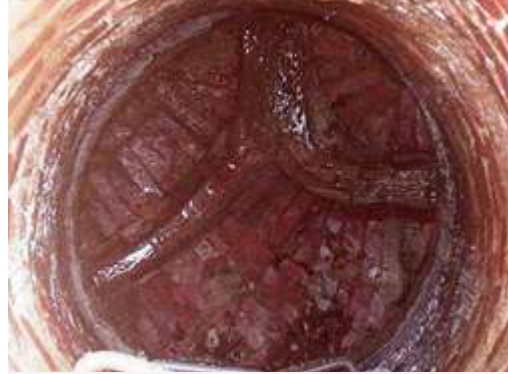
Top View

Evidence of surcharge - Bench debris.

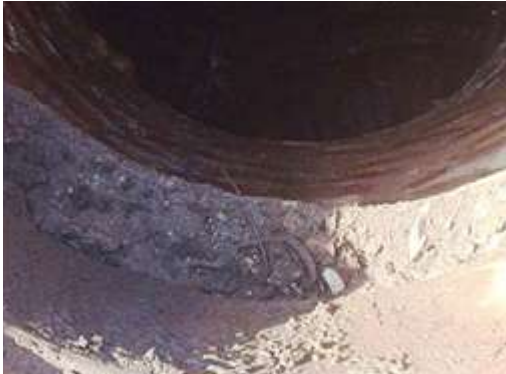
Defect

Frame leaks. Frame offset. Adjustment deterioration and infiltration.

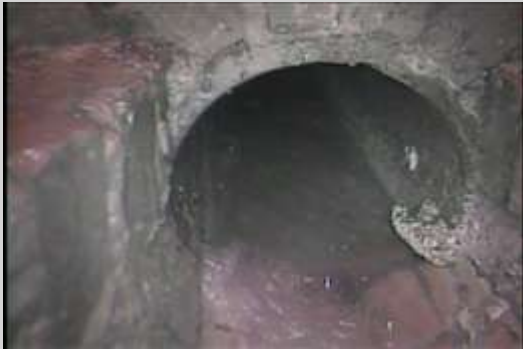
10 in. Circular Gravity Sewer Pipe Out @ 12 O'Clock

Deposits: ☐ None ☐ Mud ☐ Sludge ☐ Debris ☒ Grease

Silt Depth: **0** (in.) Deposits Extent: **Light**

Infiltration: **Evidence** Pipe Seal Cond: **Unknown**

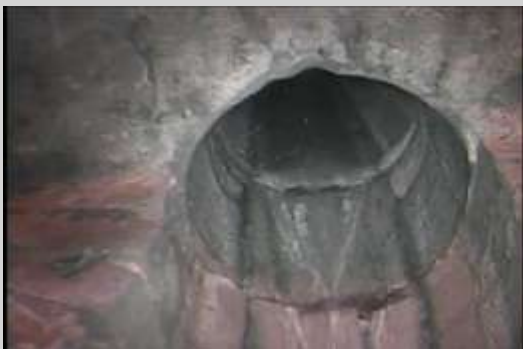
10 in. Circular Gravity Sewer Pipe In @ 3 O'Clock

Infiltration: **Evidence** Pipe Seal Cond: **Cracked**

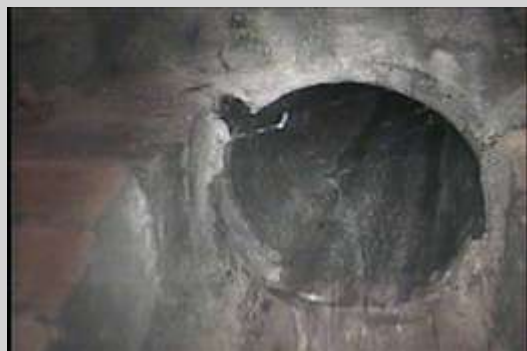
Pipe In @ 8 O'Clock

Infiltration: **Evidence**
